**Flood Control Project Maintenance  
Levee Inspections**

## Maintenance Issue Types Only, Levee Inspection Report By Mile - Spring 2019

### Reclamation District No. 0501 Ryer Island

Waterway	Bank	Unit Miles	Inspection Start/End	Inspector
Unit No. 01 Steamboat Slough	Right	6.71	03/12/2019 03/12/2019	David Julian

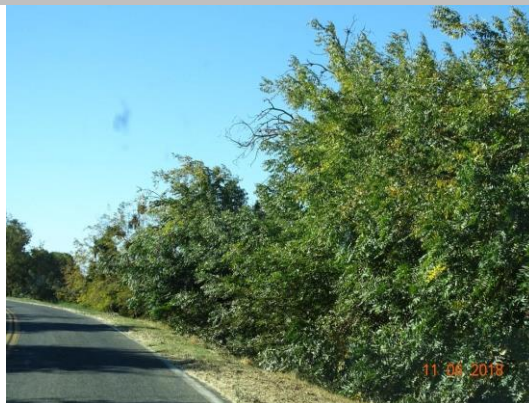
Photo 1 of 1 : SP\_2019\_RD0501\_169\_42\_20190311\_00010.jpg

LM Start	0.06	Rating **	M	Issue No.	42
LM End	0.08	Issue Type +	Ma	Location *	LS
Category	Earthen Levee			GPS Latitude/Longitude	
				Start	End
Item	Trim / Thin Trees			38.253783 °	38.253525 °
				-121.602077 °	-121.602265 °
DWR ID	DWR_RD0501_01_f_2018_42				
Comment Code					
T2 : Thin trees to allow visibility of the ground and room to flood fight.					
Inspector Comment

View looking downstream at relatively thick trees on the landside slope (November 2018).

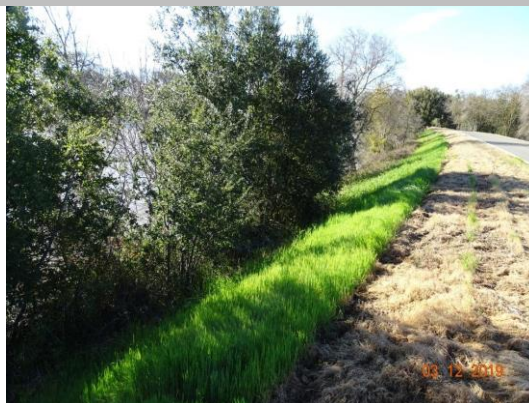
Photo 1 of 1 : SP\_2019\_RD0501\_169\_24\_20190314\_00066.jpg

LM Start	0.11	Rating **	M	Issue No.	24
LM End	0.11	Issue Type +	Ma	Location *	WS
Category	Earthen Levee			GPS Latitude/Longitude	
				Start	End
Item	Trim / Thin Trees			38.253217 °	38.253217 °
				-121.602480 °	-121.602480 °
DWR ID	DWR_RD0501_01_s_2019_24				
Comment Code					
T1 : Trim trees to at least five feet above ground level.					
Inspector Comment					
Trim trees within 20 feet of the crown.

View looking downstream at trees within 20' of the levee crown (Spring 2019).

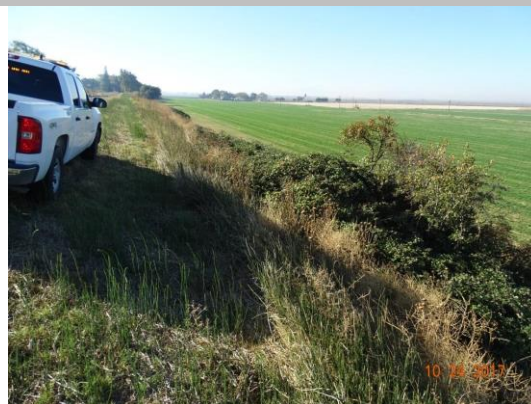
Photo 1 of 1 : SP\_2019\_RD0501\_169\_29\_20190311\_00004.jpg

LM Start	0.76	Rating **	M	Issue No.	29
LM End	1.01	Issue Type +	Ma	Location *	LS
Category	Earthen Levee			GPS Latitude/Longitude	
				Start	End
Item	Vegetation			38.243815 °	38.240257 °
				-121.603077 °	-121.603873 °
DWR ID	DWR_RD0501_01_f_2018_29				
Comment Code					
V2 : Remove the wild growth other than native grasses from the levee slopes.					
Inspector Comment					
Landside slope is covered in blackberry vines. Should be removed to allow inspection and access.

View of landside slope covered in blackberry vines.

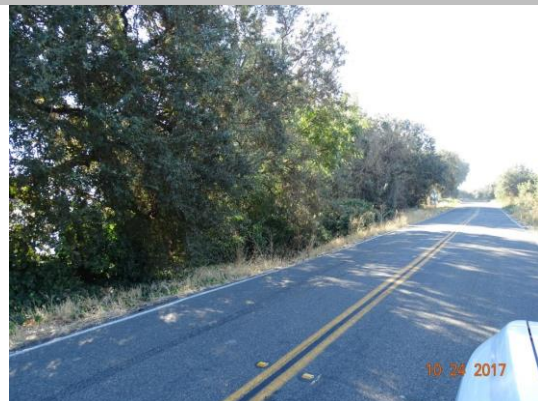
Photo 1 of 1 : SP\_2019\_RD0501\_169\_31\_20190311\_00006.jpg

LM Start	1.01	Rating **	M	Issue No.	31
LM End	1.11	Issue Type +	Ma	Location *	WS
Category	Earthen Levee			GPS Latitude/Longitude	
				Start	End
Item	Vegetation			38.240222 °	38.238918 °
				-121.603887 °	-121.604338 °
DWR ID	DWR_RD0501_01_f_2017_31				
Comment Code					
V2 : Remove the wild growth other than native grasses from the levee slopes.					
Inspector Comment					
Waterside vegetation should be thinned/removed to 20' from WS shoulder to allow inspection and access.

View of waterside vegetation.

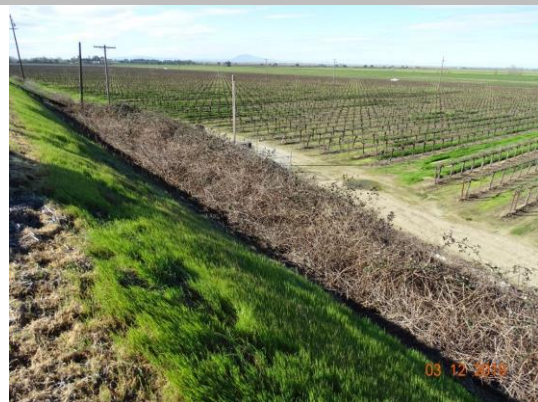
Photo 1 of 1 : SP\_2019\_RD0501\_169\_35\_20190314\_00068.jpg

LM Start	1.83	Rating **	M	Issue No.	35
LM End	1.83	Issue Type +	Ma	Location *	LS
Category	Earthen Levee			GPS Latitude/Longitude	
				Start	End
Item	Vegetation			38.228612 °	38.228612 °
				-121.604120 °	-121.604120 °
DWR ID	DWR_RD0501_01_s_2019_35				
Comment Code					
V2 : Remove the wild growth other than native grasses from the levee slopes.					
Inspector Comment					
Remove blackberry bushes on the levee slope.

View looking downstream at blackberries on the landside toe (Spring 2019).

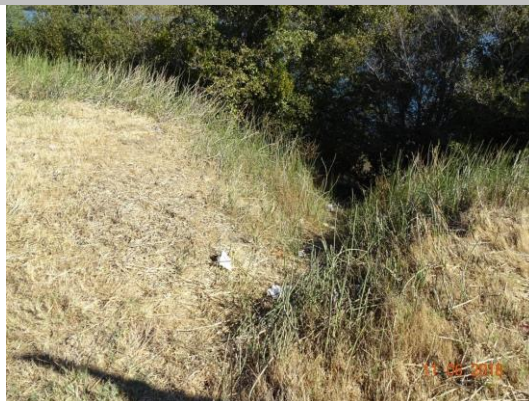
Photo 1 of 2 : SP\_2019\_RD0501\_169\_47\_20190311\_00013.jpg

LM Start	2.07	Rating **	U	Issue No.	47
LM End	2.07	Issue Type +	Ma	Location *	WS
Category	Earthen Levee			GPS Latitude/Longitude	
				Start	End
Item	Slope Stability			38.225070 °	38.225070 °
				-121.603827 °	-121.603827 °
DWR ID	DWR_RD0501_01_f_2018_47				
Comment Code					
S2 : Repair the levee slope damaged by foot traffic and prevent access where possible.					
Inspector Comment					
Deep gouges in the waterside slope due to heavy foot traffic. LMA put sign up to deter foot traffic and it has been effective.

View of foot path that is more than 1 foot deep into the waterside slope (November 2018).

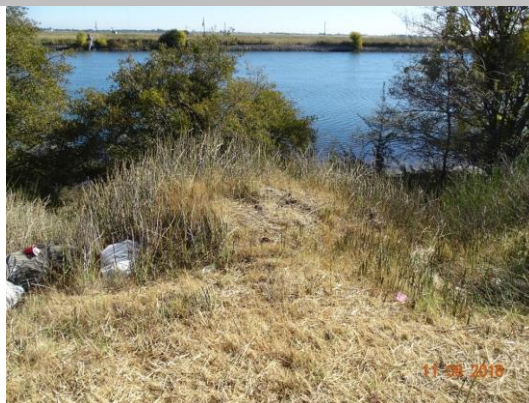
Photo 2 of 2 : SP\_2019\_RD0501\_169\_47\_20190311\_00014.jpg

View of two additional foot paths that are more than 1 foot deep into the waterside slope (November 2018).

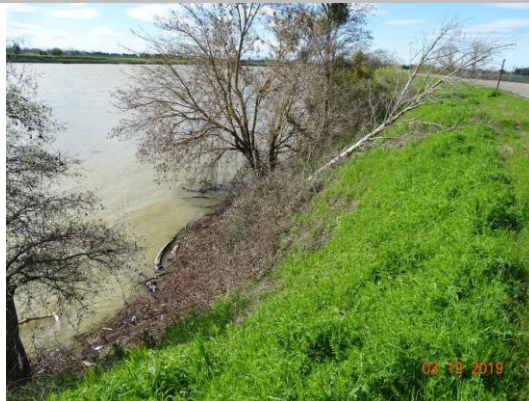
Photo 1 of 2 : SP\_2019\_RD0501\_169\_21\_20190314\_00073.jpg

LM Start	5.77	Rating **	M	Issue No.	21		
LM End	5.84	Issue Type +	Ma	Location *	WS		
Category	Supplemental			GPS Latitude/Longitude			
				Start	End		
Item	2017 USACE Erosion Survey, DRAFT			38.190001	°	38.189311	°
				-121.643160	°	-121.643917	°
DWR ID	DWR_RD0501_01_f_2018_21						
Comment Code							
Inspector Comment							
2017 Site ID: STM 15.7 R							
Status: Eroding							
2017 Field Notes: No observed change.							
Site History: 2008 - Overstepped levee section with multiple small pockets of erosion 10 - 20 ft wide. 2013 - Site has fresh erosion and taller vertical sections.							
Spring 2019 Notes: Tree fallen next to worst of erosion spot during February highwater events

View looking downstream at tree that recently fell next to worst of the erosion spots. Tree fell during the February 2019 highwater events (Spring 2019).

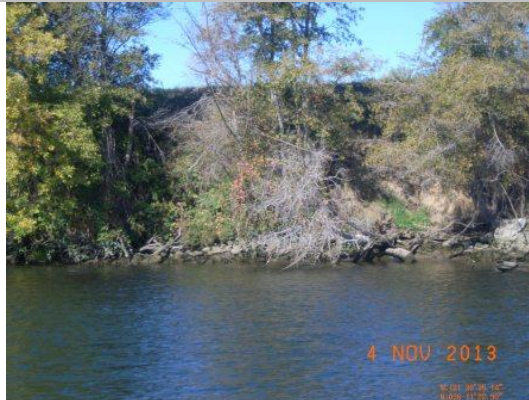
Photo 2 of 2 : SP\_2019\_RD0501\_169\_21\_20190311\_00002.jpg

USACE 2013 Photo #1

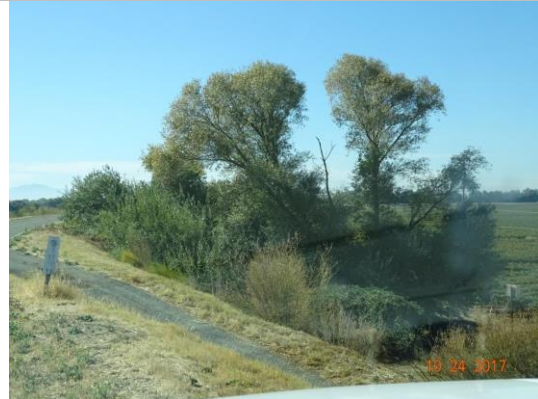
Photo 1 of 1 : SP\_2019\_RD0501\_169\_38\_20190311\_00007.jpg

LM Start	5.89	Rating **	U	Issue No.	38
LM End	5.89	Issue Type +	Ma	Location *	LS
Category	Earthen Levee			GPS Latitude/Longitude	
				Start	End
Item	Trim / Thin Trees			38.188870 °	38.188870 °
				-121.644732 °	-121.644732 °
DWR ID	DWR_RD0501_01_f_2017_38				
Comment Code					
T2 : Thin trees to allow visibility of the ground and room to flood fight.					
Inspector Comment					
Trim/thin/remove trees and undergrowth to allow inspection and access to slope and toe.

View of trees and undergrowth on landside slope and toe.

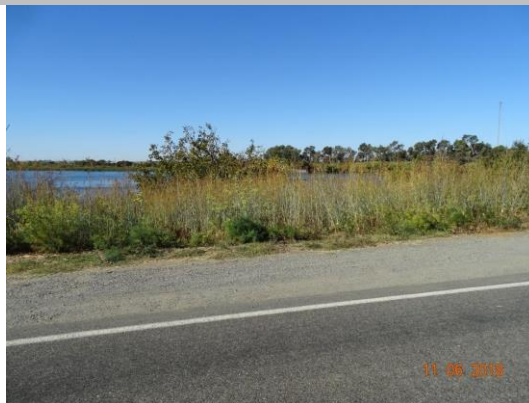
Photo 1 of 1 : SP\_2019\_RD0501\_170\_17\_20190311\_00002.jpg

View of thick vegetation at the top of the water side slope (November 2018).

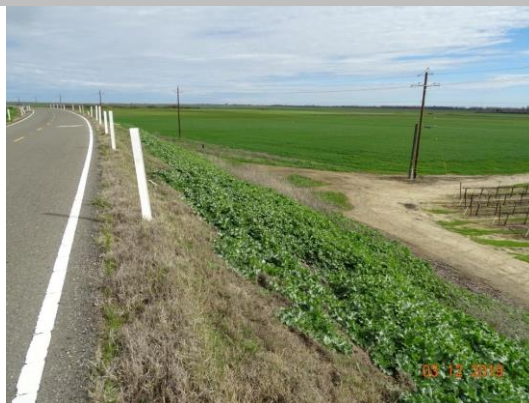
Photo 1 of 1 : SP\_2019\_RD0501\_170\_23\_20190314\_00044.jpg

LM Start	0.65	Rating **	M	Issue No.	23
LM End	0.75	Issue Type +	Ma	Location *	LS
Category	Earthen Levee			GPS Latitude/Longitude	
				Start	End
Item	Vegetation			38.192630 °	38.194068 °
				-121.655452 °	-121.655160 °
DWR ID	DWR_RD0501_02_s_2019_23				
Comment Code					
V1 : Control annual grass and weeds on the levee slopes and easements.					
Inspector Comment					
Remove annual vegetation from landside slope.

View looking upstream at vegetation on the landside slope (Spring 2019).

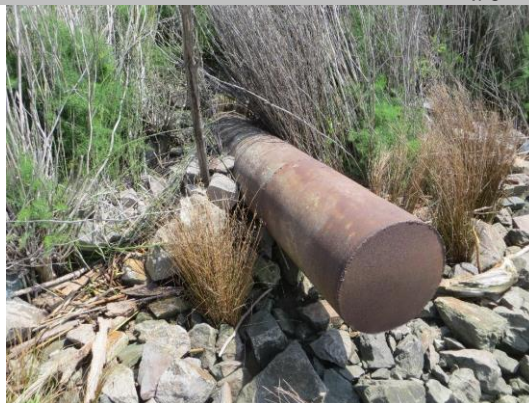
Photo 1 of 3 : UCIP\_SP\_2019\_44753\_73955.jpg

LM Start	1.25	Rating **	M	Issue No.	31
LM End	1.25	Issue Type +	Ma	Location *	
Category	Supplemental			GPS Latitude/Longitude	
				Start	End
Item	DWR UCIP LMA Responsibility			38.201143 °	38.201143 °
				-121.655169 °	-121.655169 °
DWR ID	21085				
Comment Code					
Inspector Comment					
FS_ID:44753 DS_ID:21085 EP_NO: N/A Repair Type: Non-Urgent Crossing Status: Found UCIP Comments: Hole rusted through pipe on WS end. Pipe abandoned and should be done so properly. FIELD_STRUCT_DESC: *ABANDONED* 20-inch coated steel gravity drainage pipe through the levee, 15.5 feet below the crown. Pipe exposed along the waterside (WS) slope. Steel plate welded over end. [Additional Reference(s): USACE Sacramento O&M Manual 105, April 1959, (HLM 1.4)]. FS Date: 4/23/2015

20-inch pipe with welded steel plate over end on WS toe.

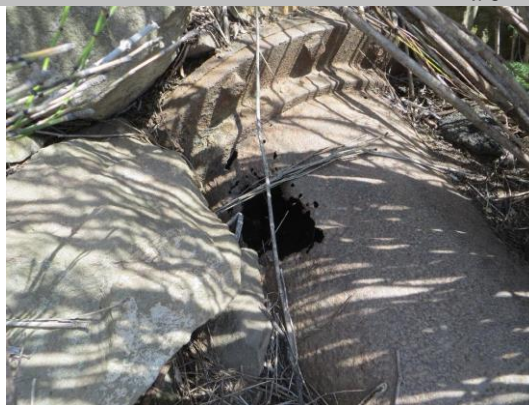
Photo 2 of 3 : UCIP\_SP\_2019\_44753\_73954.jpg

Hole in pipe at WS toe.

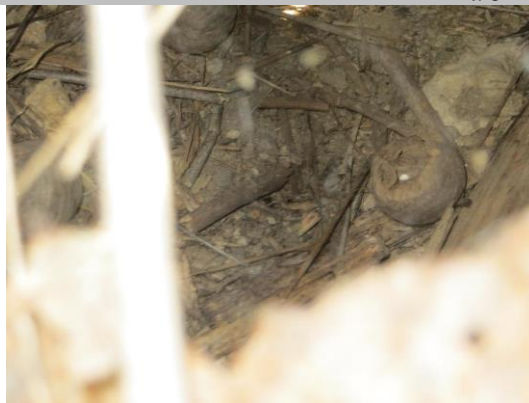
Photo 3 of 3 : UCIP\_SP\_2019\_44753\_73953.jpg

Inside hole in pipe at WS toe.

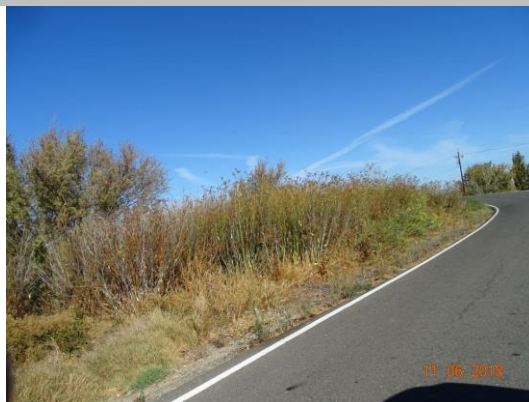
Photo 1 of 1 : SP\_2019\_RD0501\_170\_18\_20190311\_00003.jpg

LM Start	1.73	Rating **	M	Issue No.	18
LM End	1.82	Issue Type +	Ma	Location *	WS
Category	Earthen Levee			GPS Latitude/Longitude	
				Start	End
Item	Vegetation			38.208030 °	38.209040 °
				-121.656052 °	-121.655575 °
DWR ID	DWR_RD0501_02_f_2018_18				
Comment Code					
V1 : Control annual grass and weeds on the levee slopes and easements.					
Inspector Comment					
Remove vegetation from top 20' of waterside slope.

View looking upstream at vegetation on the waterside shoulder (November 2018).

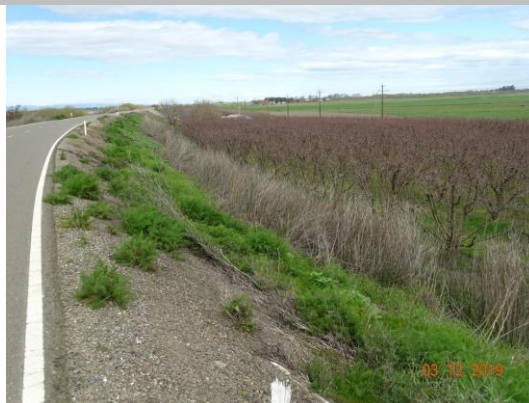
Photo 1 of 1 : SP\_2019\_RD0501\_170\_24\_20190314\_00045.jpg

View looking upstream at vegetation on the landside slope (Spring 2019).

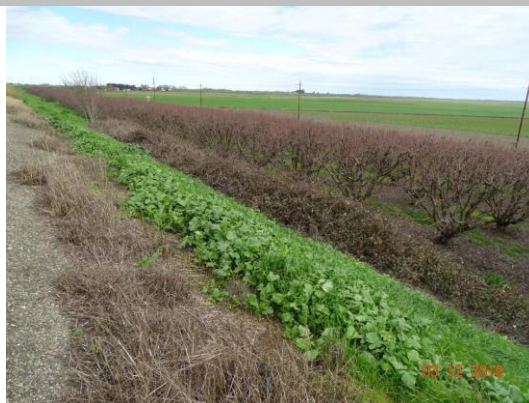
Photo 1 of 1 : SP\_2019\_RD0501\_170\_25\_20190314\_00046.jpg

LM Start	2.64	Rating **	M	Issue No.	25
LM End	2.64	Issue Type +	Ma	Location *	LS
Category	Earthen Levee			GPS Latitude/Longitude	
				Start	End
Item	Vegetation			38.215720 °	38.215720 °
				-121.667430 °	-121.667430 °
DWR ID	DWR_RD0501_02_s_2019_25				
Comment Code					
V2 : Remove the wild growth other than native grasses from the levee slopes.					
Inspector Comment					
Remove blackberries from bottom of levee slope.

View of blackberries at the landside toe (Spring 2019).

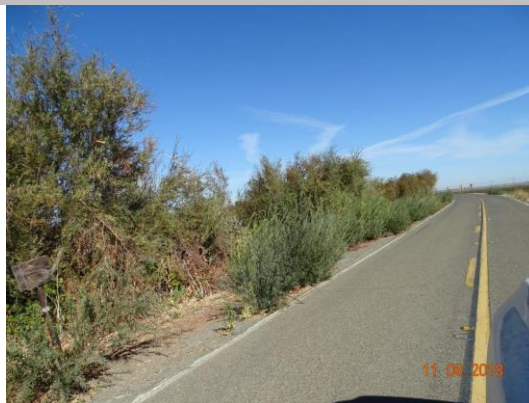
Photo 1 of 1 : SP\_2019\_RD0501\_171\_44\_20190311\_00011.jpg

View looking upstream of new willow growth on the waterside shoulder (November 2018).

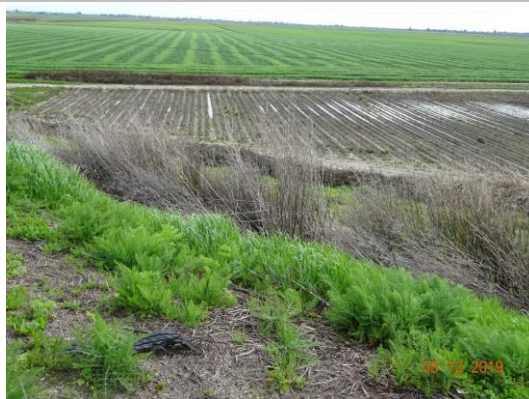
Photo 1 of 1 : SP\_2019\_RD0501\_171\_27\_20190314\_00081.jpg

LM Start	0.57	Rating **	M	Issue No.	27
LM End	0.57	Issue Type +	Ma	Location *	LS
Category	Earthen Levee			GPS Latitude/Longitude	
				Start	End
Item	Vegetation			38.234102 °	38.234102 °
				-121.665932 °	-121.665932 °
DWR ID	DWR_RD0501_03_s_2019_27				
Comment Code					
V2 : Remove the wild growth other than native grasses from the levee slopes.					
Inspector Comment					
Remove vegetation from the landside slope.

View of vegetation on the landside slope (Spring 2019).

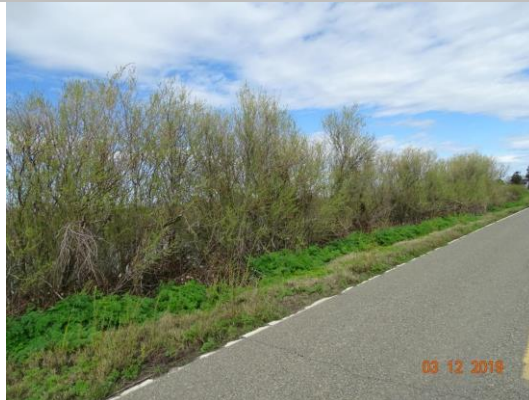
Photo 1 of 1 : SP\_2019\_RD0501\_171\_30\_20190314\_00082.jpg

LM Start	0.78	Rating **	U	Issue No.	30
LM End	0.93	Issue Type +	Ma	Location *	WS
Category	Earthen Levee			GPS Latitude/Longitude	
				Start	End
Item	Vegetation			38.236968 °	38.239040 °
				-121.665088 °	-121.664862 °
DWR ID	DWR_RD0501_03_s_2019_30				
Comment Code					
V2 : Remove the wild growth other than native grasses from the levee slopes.					
Inspector Comment					
Remove willows and blackberries 20' from crown.

View looking upstream at vegetation on the waterside slope (Spring 2019).

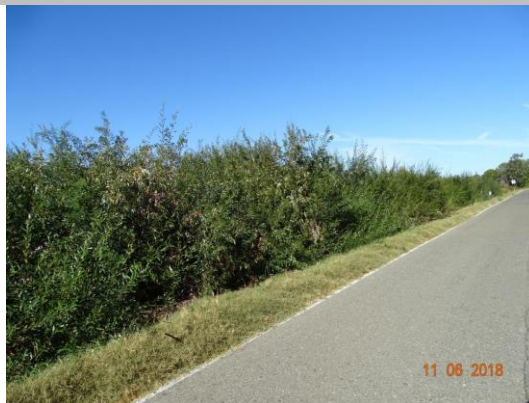
Photo 1 of 1 : SP\_2019\_RD0501\_171\_45\_20190311\_00012.jpg

View looking upstream at thick vegetation on the waterside slope (November 2018).

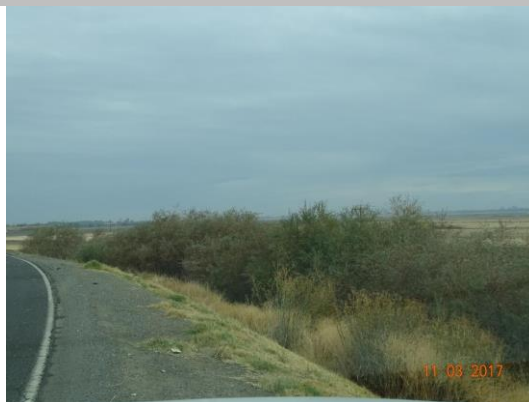
Photo 1 of 1 : SP\_2019\_RD0501\_171\_28\_20190311\_00001.jpg

LM Start	1.48	Rating **	M	Issue No.	28	
LM End	1.48	Issue Type +	Ma	Location *	LS	
Category	Earthen Levee			GPS Latitude/Longitude		
				Start		End
Item	Trim / Thin Trees			38.244293 °		38.244293 °
				-121.657843 °		-121.657843 °
DWR ID	DWR_RD0501_03_f_2017_28					
Comment Code						
T2 : Thin trees to allow visibility of the ground and room to flood fight.						
Inspector Comment						
Trim/thin willows to allow inspection and access to landside slope and toe.

Trim/thin willows to allow inspection and access to landside slope and toe.

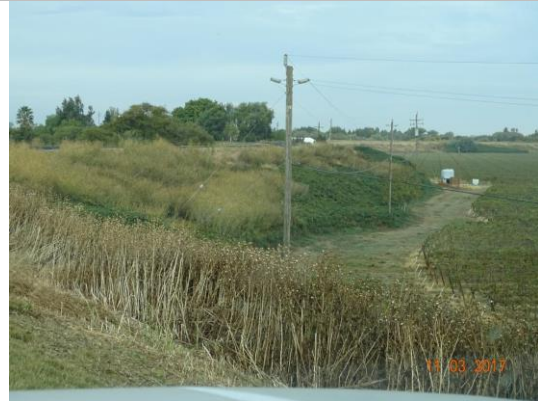
Photo 1 of 1 : SP\_2019\_RD0501\_171\_34\_20190311\_00005.jpg

Photo of berry vines on landside slope and toe

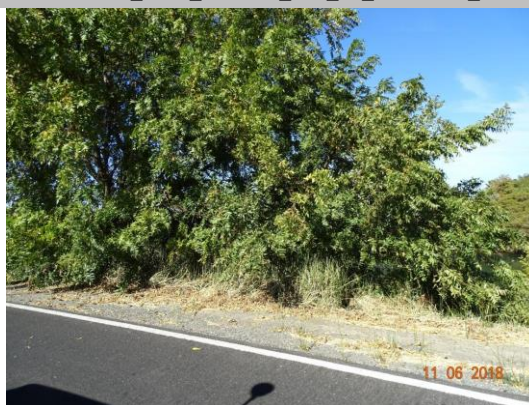
Photo 1 of 1 : SP\_2019\_RD0501\_171\_49\_20190311\_00014.jpg

View of thick tree growth on the waterside slope (November 2018).

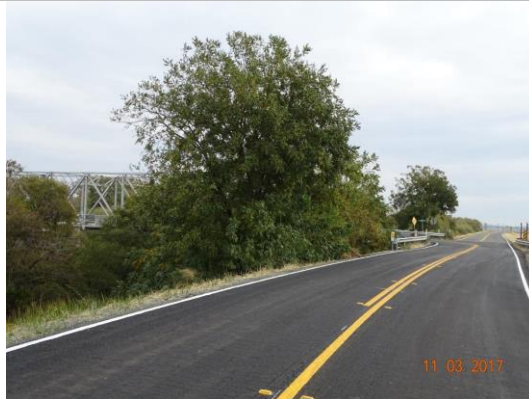
Photo 1 of 1 : SP\_2019\_RD0501\_171\_40\_20190311\_00008.jpg

Photo of trees on waterside slope

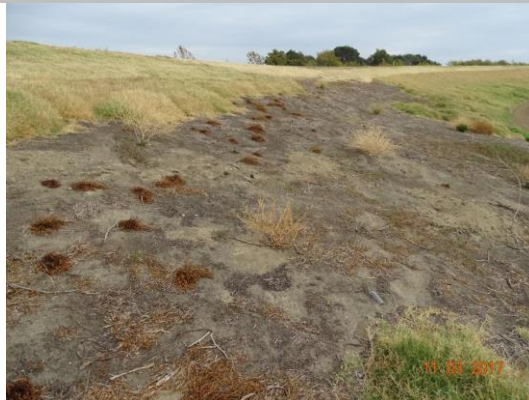
Photo 1 of 1 : SP\_2019\_RD0501\_171\_39\_20190311\_00007.jpg

LM Start	6.61	Rating **	M	Issue No.	39
LM End	6.61	Issue Type +	Ma	Location *	LS
Category	Earthen Levee			GPS Latitude/Longitude	
				Start	End
Item	Animal Control			38.290313 °	38.290313 °
				-121.623785 °	-121.623785 °
DWR ID	DWR_RD0501_03_f_2016_39				
Comment Code					
A1 : Exterminate rodents and backfill and compact or grout burrows.					
Inspector Comment					
There is evidence of significant rodent activity at this location. Exterminate the rodents and backfill the holes.

Phot of evidence of significant rodent activity at this location

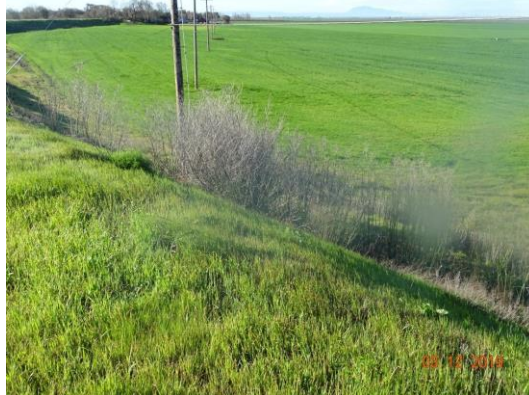
Photo 1 of 1 : SP\_2019\_RD0501\_172\_22\_20190314\_00034.jpg

View looking downstream at vegetation on the land side slope (Spring 2019).

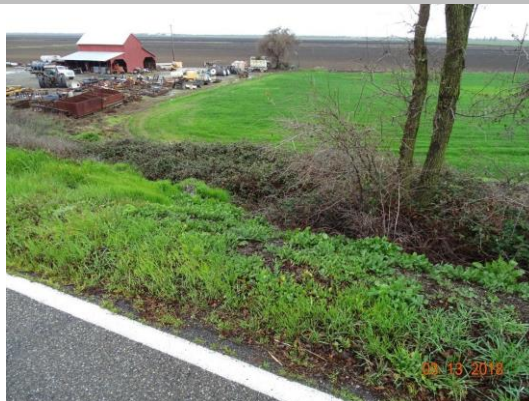
Photo 1 of 1 : SP\_2019\_RD0501\_172\_11\_20190311\_00001.jpg

LM Start	0.84	Rating **	M	Issue No.	11
LM End	0.84	Issue Type +	Ma	Location *	LS
Category	Earthen Levee			GPS Latitude/Longitude	
				Start	End
Item	Vegetation			38.274615 °	38.274615 °
				-121.602718 °	-121.602718 °
DWR ID	DWR_RD0501_04_f_2017_11				
Comment Code					
V2 : Remove the wild growth other than native grasses from the levee slopes.					
Inspector Comment					
Remove thick blackberries at landside toe to allow inspection and access.

Thick blackberries should be removed.

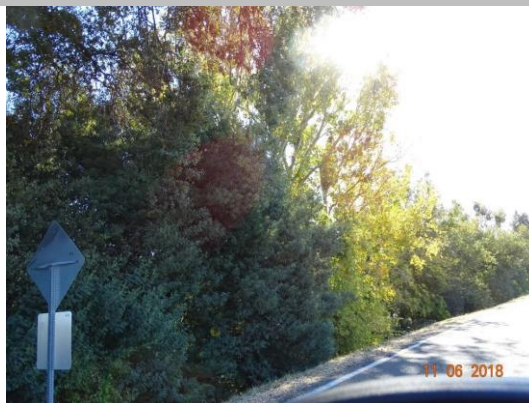
Photo 1 of 1 : SP\_2019\_RD0501\_172\_20\_20190311\_00006.jpg

View looking downstream at thick trees on the waterside slope (November 2018)
